**Flood Control Project Maintenance
Levee Inspections**

Maintenance Issue Types Only, Levee Inspection Report By Mile - Fall 2016

Sutter Maintenance Yard Maintenance Area 0003

Waterway	Bank	Unit Miles	Inspection Start/End	Inspector
Unit No. 01 Feather River	Right	5.11	10/04/2016 10/04/2016	Sterling York

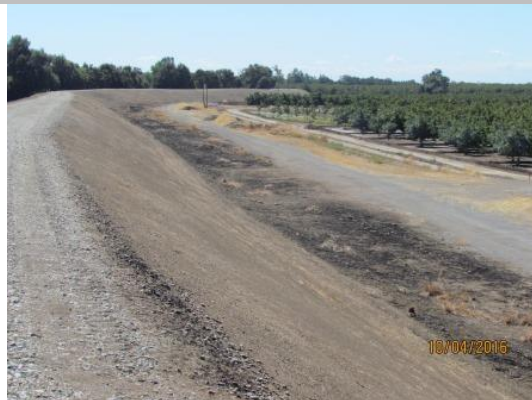
Photo 1 of 1 : FA_2016_MA0003_195_11_20161007_00026.jpg

LM Start	0.01	Rating **	A	Issue No.	11
LM End	5.11	Issue Type +	Ma	Location *	LS
Category	Earthen Levee			GPS Latitude/Longitude	
				Start	End
Item	Vegetation			38.897990 °	38.950968 °
				-121.617822 °	-121.585754 °
DWR ID	DWR_MA0003_01_f_2016_11				
Comment Code					
V1 : Control annual grass and weeds on the levee slopes and easements.					
Inspector Comment					
Very well maintained vegetation. Fall 2016.

View of very well maintained vegetation, landside looking downstream.
Fall 2016.*** Location**

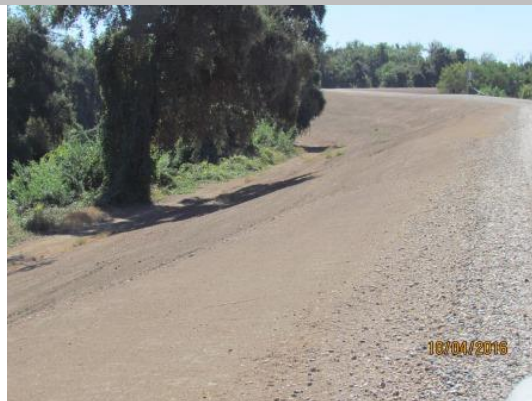
Photo 1 of 1 : FA_2016_MA0003_195_12_20161007_00027.jpg

LM Start	0.01	Rating **	A	Issue No.	12
LM End	5.11	Issue Type +	Ma	Location *	WS
Category	Earthen Levee			GPS Latitude/Longitude	
				Start	End
Item	Vegetation			38.897990°	38.950968°
				-121.617822°	-121.585754°
DWR ID	DWR_MA0003_01_f_2016_12				
Comment Code					
V1 : Control annual grass and weeds on the levee slopes and easements.					
Inspector Comment					
Very well maintained vegetation. Fall 2016.

View of very well maintained vegetation, waterside looking downstream. Fall 2016.

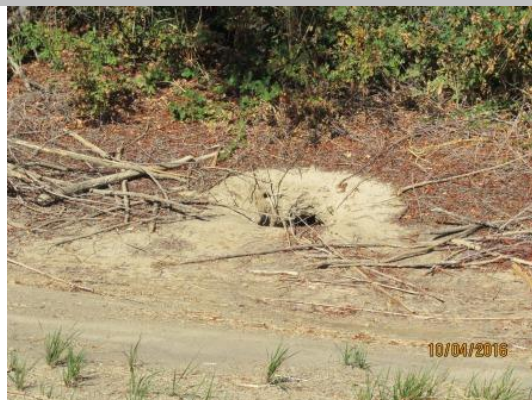
Photo 1 of 2 : FA_2016_MA0003_195_140_20161007_00038.jpg

LM Start	0.78	Rating **	M	Issue No.	140
LM End	0.78	Issue Type +	Ma	Location *	LS
Category	Earthen Levee			GPS Latitude/Longitude	
				Start	End
Item	Animal Control			38.903339 °	38.903339 °
				-121.606209 °	-121.606209 °
DWR ID	DWR_MA0003_01_f_2014_140				
Comment Code					
A3 : No rodents visible, but rodent burrows visible; need to backfill and compact or grout burrows.					
Inspector Comment					
There is a rodent hole on the landward toe road approximately 8" in diameter that needs to be repaired. Fall 2016.

This photo was taken from the landward levee slope near the toe road facing north looking at an approximately 8" rodent hole. Fall 2016.

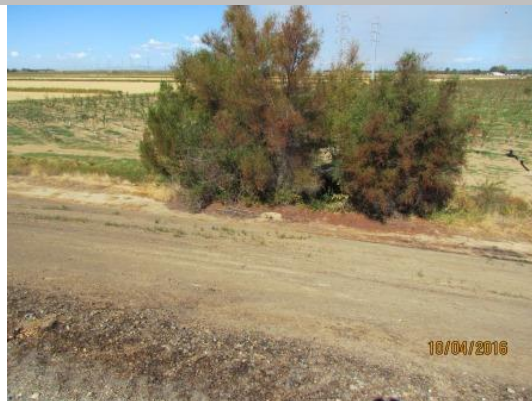
Photo 2 of 2 : FA_2016_MA0003_195_140_20161007_00039.jpg

LM Start	0.78	Rating **	M	Issue No.	140 (cont)	
LM End	0.78	Issue Type +	Ma	Location *	LS	
Category	Earthen Levee			GPS Latitude/Longitude		
				Start	End	
Item	Animal Control			38.903339 °	38.903339 °	
				-121.606209 °	-121.606209 °	
DWR ID	DWR_MA0003_01_f_2014_140					
Comment Code						
A3 : No rodents visible, but rodent burrows visible; need to backfill and compact or grout burrows.						
Inspector Comment						
There is a rodent hole on the landward toe road approximately 8" in diameter that needs to be repaired. Fall 2016.

This is another photo of the rodent hole to show its relationship to to levee toe, toe road, and drainage ditch. Fall 2016.

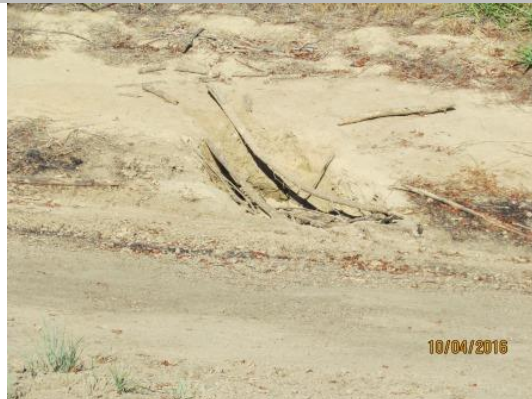
Photo 1 of 2 : FA_2016_MA0003_195_21_20161007_00035.jpg

LM Start	0.80	Rating **	M	Issue No.	21
LM End	0.80	Issue Type +	Ma	Location *	LS
Category	Earthen Levee			GPS Latitude/Longitude	
				Start	End
Item	Animal Control			38.903277°	38.903277°
				-121.605864°	-121.605864°
DWR ID	DWR_MA0003_01_f_2016_21				
Comment Code					
A3 : No rodents visible, but rodent burrows visible; need to backfill and compact or grout burrows.					
Inspector Comment					
Repair animal hole at landside levee toe. Fall 2016.

View of large hole at the landside levee toe. Look to be cause by a larger animal other than squirrels. Fall 2016.

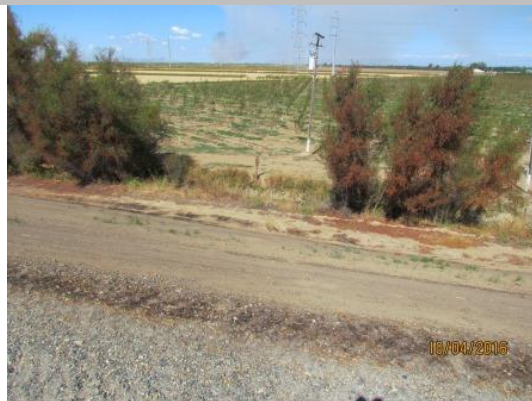
Photo 2 of 2 : FA_2016_MA0003_195_21_20161007_00037.jpg

LM Start	0.80	Rating **	M	Issue No.	21 (cont)	
LM End	0.80	Issue Type +	Ma	Location *	LS	
Category	Earthen Levee			GPS Latitude/Longitude		
				Start		End
Item	Animal Control			38.903277 °		38.903277 °
				-121.605864 °		-121.605864 °
DWR ID	DWR_MA0003_01_f_2016_21					
Comment Code						
A3 : No rodents visible, but rodent burrows visible; need to backfill and compact or grout burrows.						
Inspector Comment						
Repair animal hole at landside levee toe. Fall 2016.

View from the crown of where this hole is. Fall 2016.

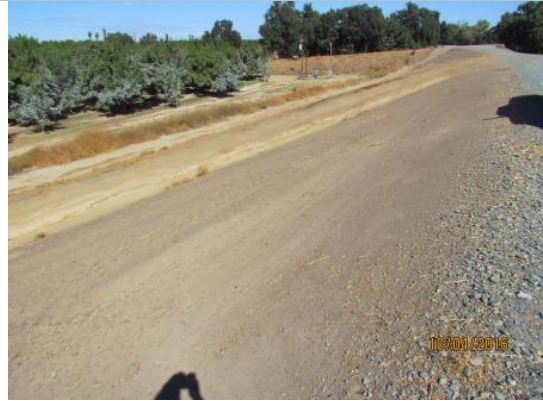
Photo 1 of 1 : FA_2016_MA0003_195_14_20161007_00033.jpg

LM Start	1.77	Rating **	A/W	Issue No.	14
LM End	1.77	Issue Type +	Ma	Location *	LS
Category	Earthen Levee			GPS Latitude/Longitude	
				Start	End
Item	Animal Control			38.907025 °	38.907025 °
				-121.590375 °	-121.590375 °
DWR ID	DWR_MA0003_01_s _ 2015_14				
Comment Code					
A3 : No rodents visible, but rodent burrows visible; need to backfill and compact or grout burrows.					
Inspector Comment					
Rodent holes have been backfilled and no new evidenced of activity. Fall 2016.

Rodent holes were backfilled and no longer exist at this location. Fall 2016.

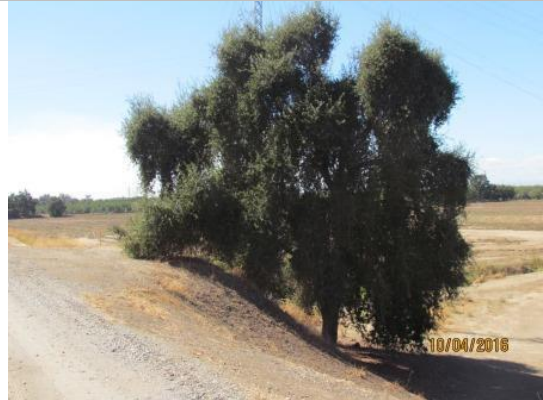
Photo 1 of 1 : FA_2016_MA0003_195_15_20161007_00030.jpg

LM Start	2.18	Rating **	M	Issue No.	15
LM End	2.18	Issue Type +	Ma	Location *	WS
Category	Earthen Levee			GPS Latitude/Longitude	
				Start	End
Item	Trim / Thin Trees			38.911869 °	38.911869 °
				-121.586093 °	-121.586093 °
DWR ID	DWR_MA0003_01_s_2015_15				
Comment Code					
T1 : Trim trees to at least five feet above ground level.					
Inspector Comment					
Tree is at a turnout and not in the levee, but limbs should be trimmed for access and visibility.

View of tree at a turnout that needs to have its limbs trimmed for visibility and access, landside looking downstream. Fall 2016.

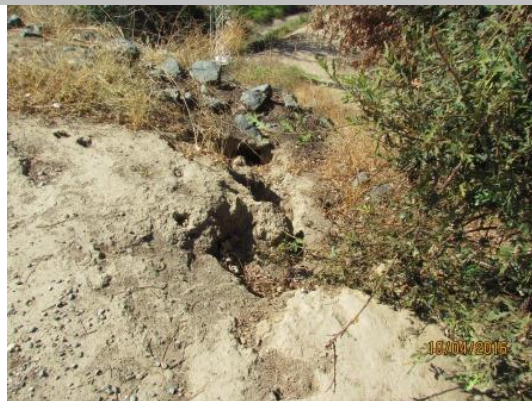
Photo 1 of 1 : FA_2016_MA0003_195_18_20161007_00031.jpg

LM Start	2.18	Rating **	M	Issue No.	18
LM End	2.18	Issue Type +	Ma	Location *	LS
Category	Earthen Levee			GPS Latitude/Longitude	
				Start	End
Item	Animal Control			38.911869 °	38.911869 °
				-121.586093 °	-121.586093 °
DWR ID	DWR_MA0003_01_s_2015_18				
Comment Code					
A3 : No rodents visible, but rodent burrows visible; need to backfill and compact or grout burrows.					
Inspector Comment

View of rodent holes that need to be backfilled, No evidence of rodents during inspection. Fall 2016.

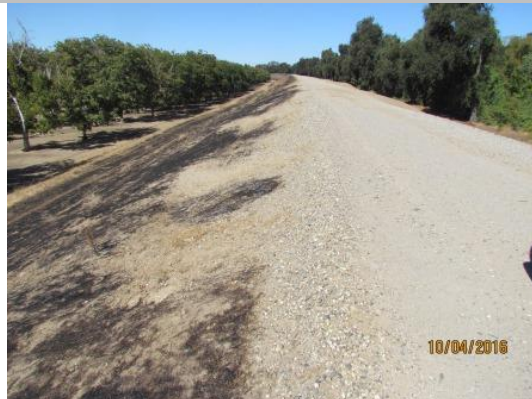
Photo 1 of 1 : FA_2016_MA0003_195_20_20161007_00029.jpg

LM Start	3.20	Rating **	A/W	Issue No.	20
LM End	3.20	Issue Type +	Ma	Location *	LS
Category	Earthen Levee			GPS Latitude/Longitude	
				Start	End
Item	Slope Stability			38.925909 °	38.925909 °
				-121.585401 °	-121.585401 °
DWR ID	DWR_MA0003_01_s_2015_20				
Comment Code					
S1 : Repair slope instability.					
Inspector Comment

View of the slope that is not consistent it makes the crown narrower were it dips in and out, but no evidence of slope erosion or sloughing. Fall 2016.

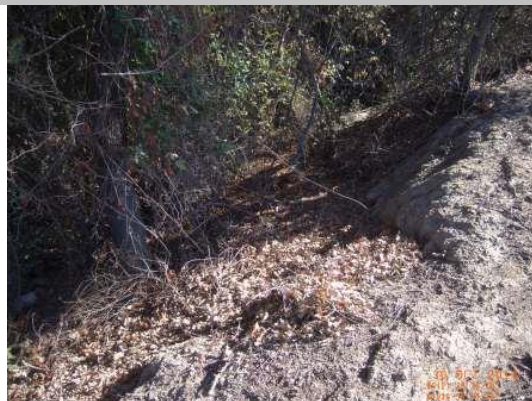
Photo 1 of 2 : FA_2016_MA0003_195_1_20160906_00001.jpg

LM Start	4.15	Rating **	M	Issue No.	1
LM End	4.18	Issue Type +	Ma	Location *	WS
Category	Supplemental			GPS Latitude/Longitude	
				Start	End
Item	2015 USACE Erosion Survey, DRAFT			38.937451°	38.937937°
				-121.588512°	-121.588471°
DWR ID	DWR_MA0003_01_s_2016_1				
Comment Code					
Inspector Comment					
2013 - Minor toe scour causing gradual erosion of bank slope. Site is within ecological reserve. 2015: Last observed in 2013. [2015 Site ID: FHR_12-3_R]

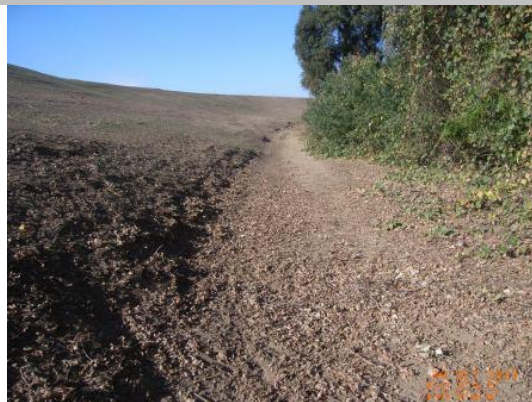
Photo 1 of 2 : FA_2016_MA0003_195_2_20160906_00003.jpg

LM Start	4.71	Rating **	M	Issue No.	2
LM End	4.76	Issue Type +	Ma	Location *	WS
Category	Supplemental			GPS Latitude/Longitude	
				Start	End
Item	2015 USACE Erosion Survey, DRAFT			38.945188 °	38.945958 °
				-121.586096 °	-121.586394 °
DWR ID	DWR_MA0003_01_s_2016_2				
Comment Code					
Inspector Comment					
2013 - Minor toe scour causing gradual erosion into the bank slope.					
2015: Last observed in 2013. [2015 Site ID: FHR_12-8_R]

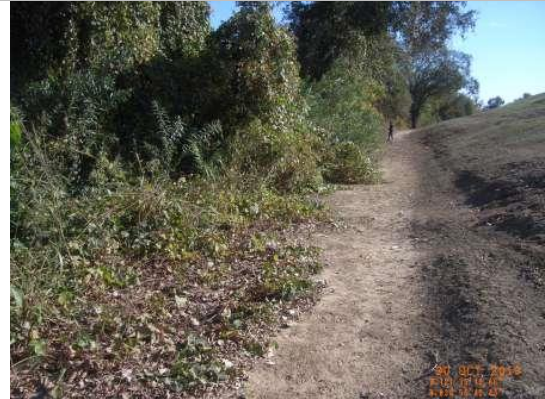
Photo 2 of 2 : FA_2016_MA0003_195_2_20160906_00004.jpg

LM Start	4.71	Rating **	M	Issue No.	2 (cont)	
LM End	4.76	Issue Type +	Ma	Location *	WS	
Category	Supplemental			GPS Latitude/Longitude		
				Start	End	
Item	2015 USACE Erosion Survey, DRAFT			38.945188°	38.945958°	
				-121.586096°	-121.586394°	
DWR ID	DWR_MA0003_01_s_2016_2					
Comment Code						
Inspector Comment						
2013 - Minor toe scour causing gradual erosion into the bank slope.						
2015: Last observed in 2013. [2015 Site ID: FHR_12-8_R]
